## Inspection Report

**Property Address:**  
4541 148th Street NE  
Marsyville WA 98271

**Preferred Home Inspection Services Inc.**

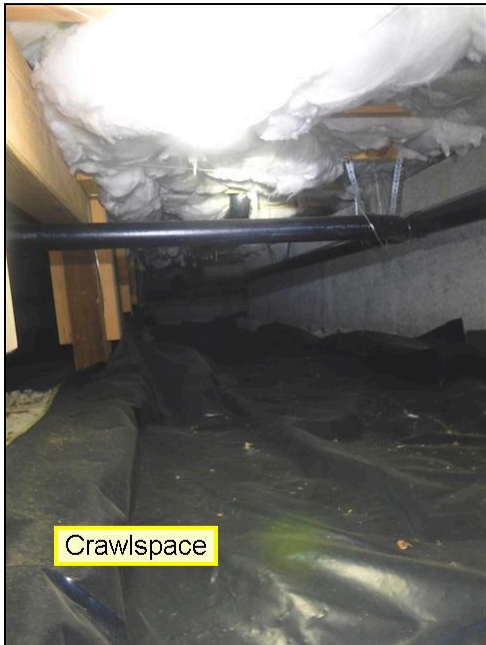
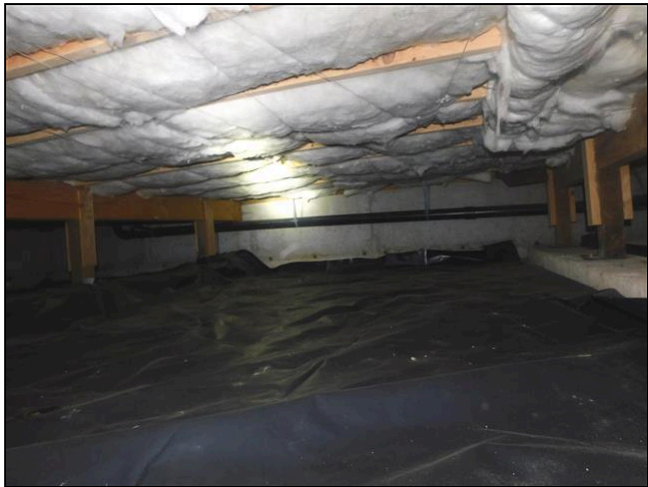
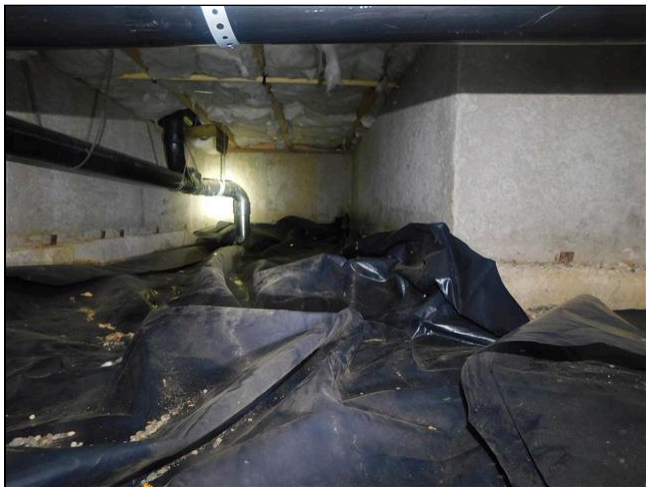
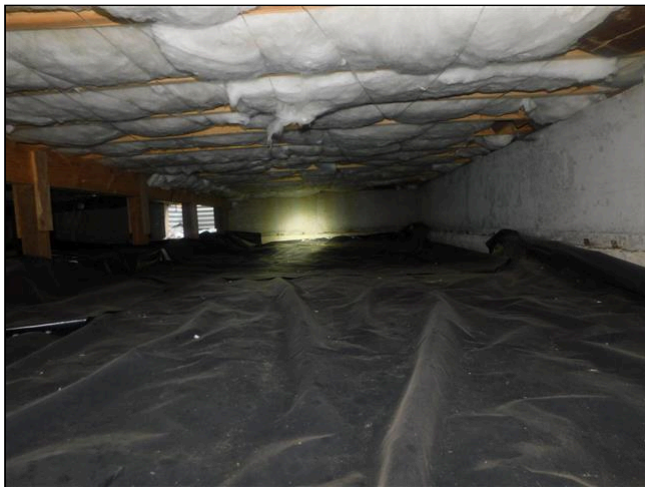
**1.1** Crawlspace clean, dry with 6 mil vapor barrier in place at the time of the inspection.

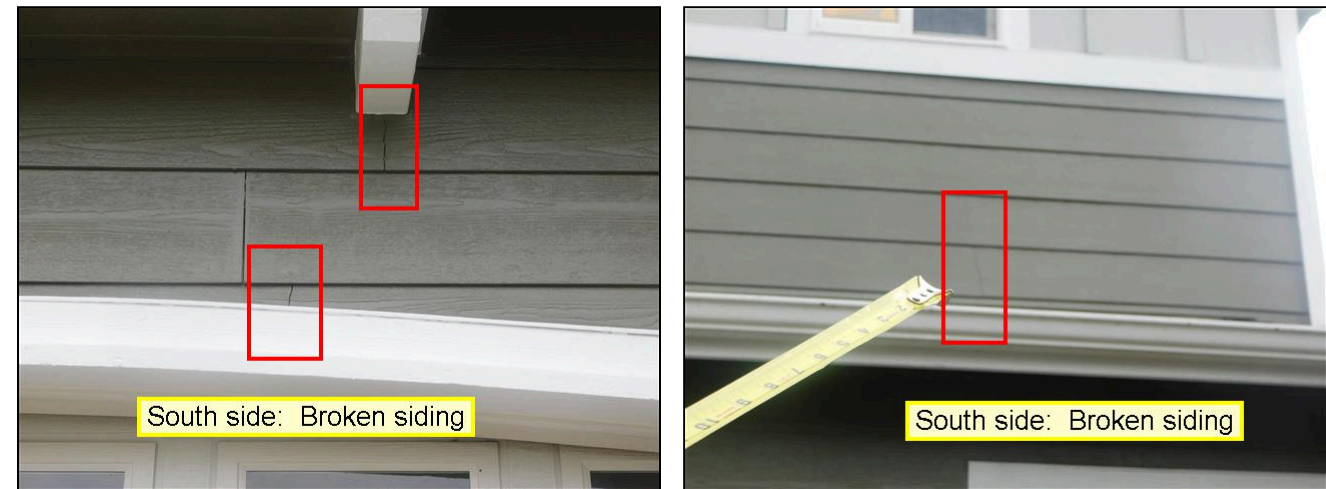
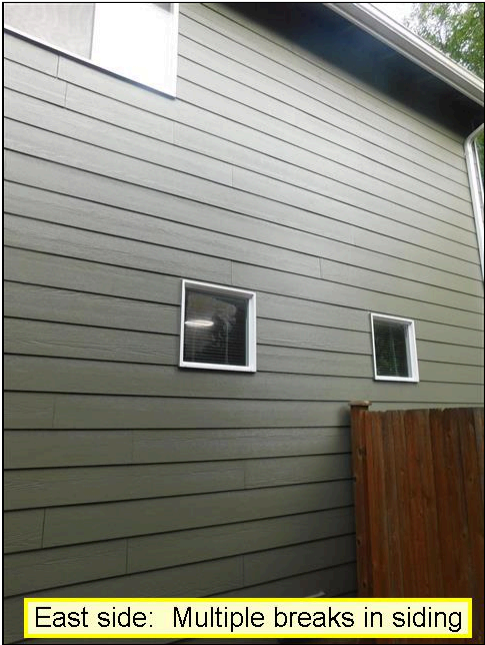
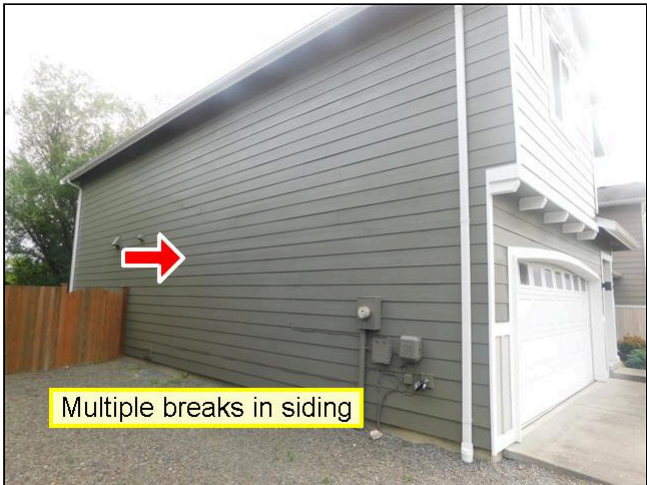
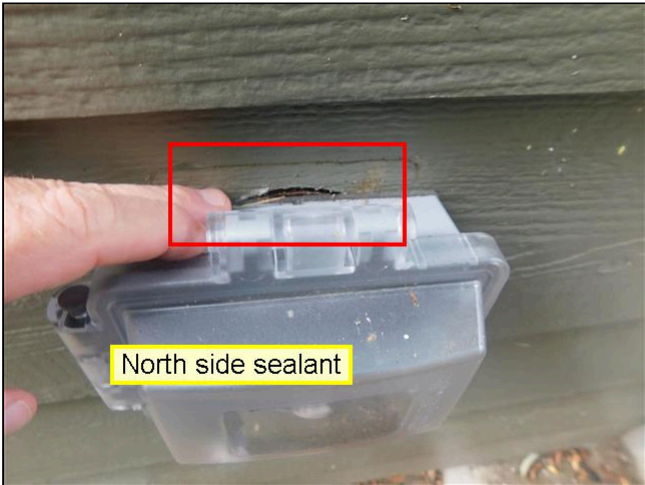
Cement siding: All butt joints: Missing butt flashing or caulking. Recommend caulking paint at all butt joints to prevent moisture from getting behind the siding. Repair.

Cement siding: Cement siding for this house has multiple breaks in the siding. Not typical. Recommend contractor to evaluate to replace and paint damaged siding. Repair.

SW upper corner: Warped vertical corner trim. Recommend replacing corner trim and paint. Repair.

North side: Gap behind concrete stoop and siding. Recommend sealant to keep moisture out of this area. Repair.

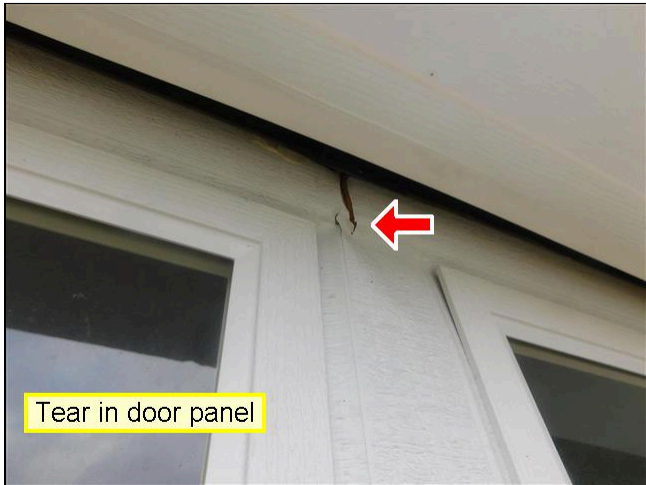
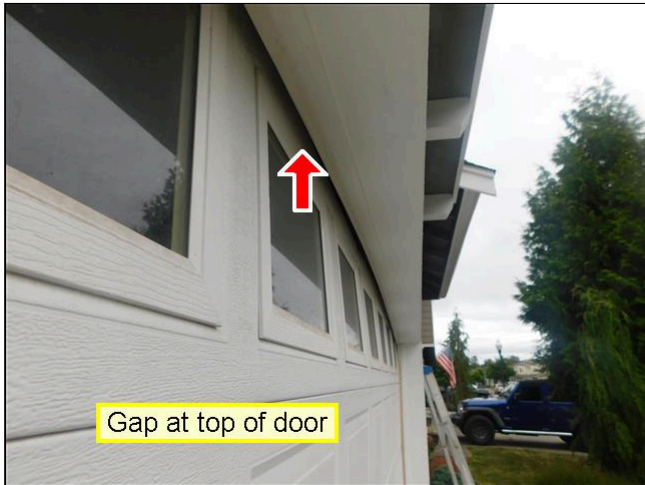
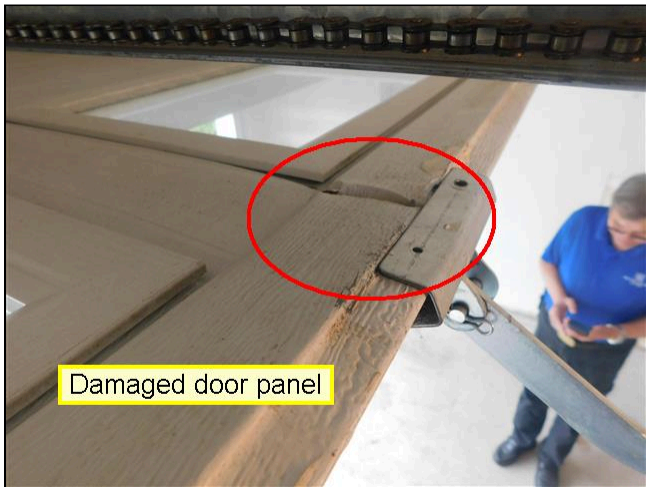
Garage door: Metal overhead door has been stressed at the top center panel. This is evident from the tear in the metal skin. Door has a one inch gap at the top of the door to wood trim. This does not appear to affect the operation of the door. Recommend repair/replace door panel as needed.

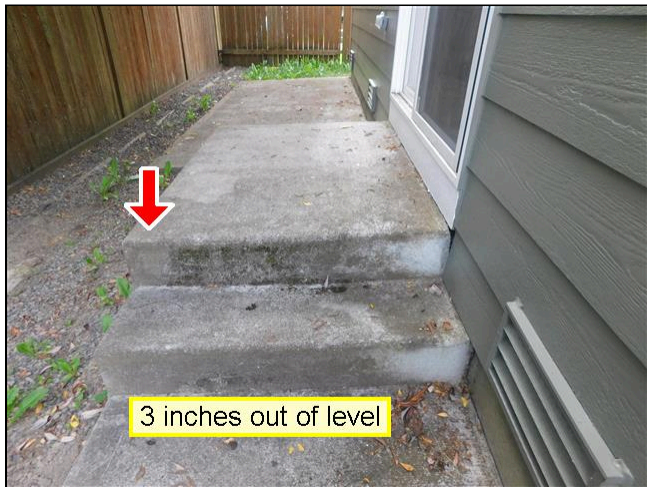
2.5 Item 1(Picture)

North side concrete patio and stoop: Concrete stoop and patio has settled away from the house and is now approximately 3 inches out of level. This is caused from the concrete stoop being installed over fill dirt. Recommend slab-jack contractor to raise concrete stoop and patio back to level position. Recommendation only.

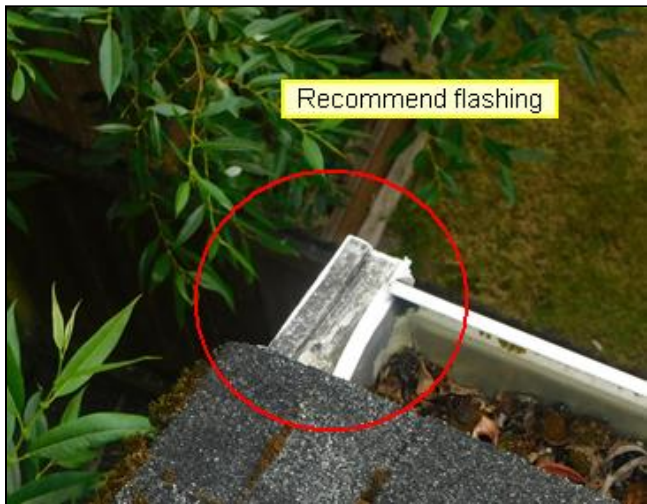
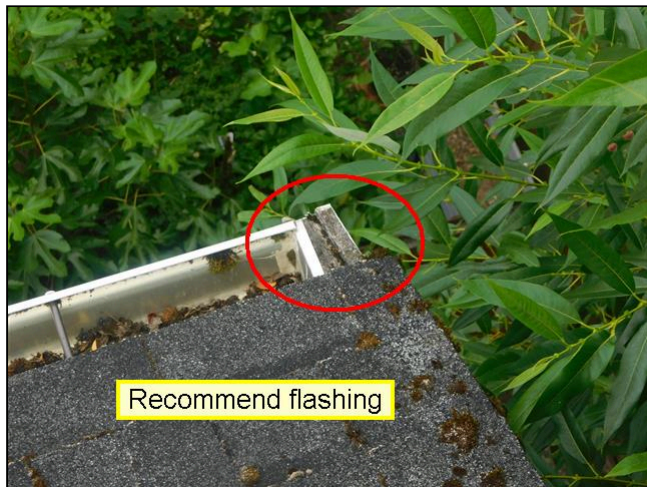
Fascia boards: Fascia boards extended at gutter end caps show typical weather damage. Recommend flashing over tops of fascia boards end cuts. Recommendation only.

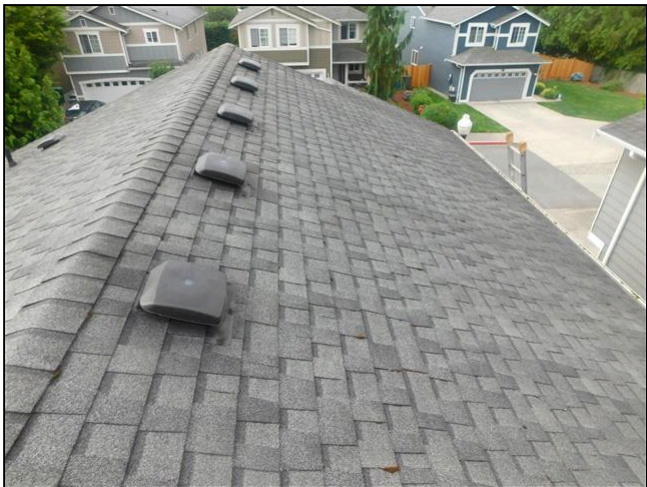
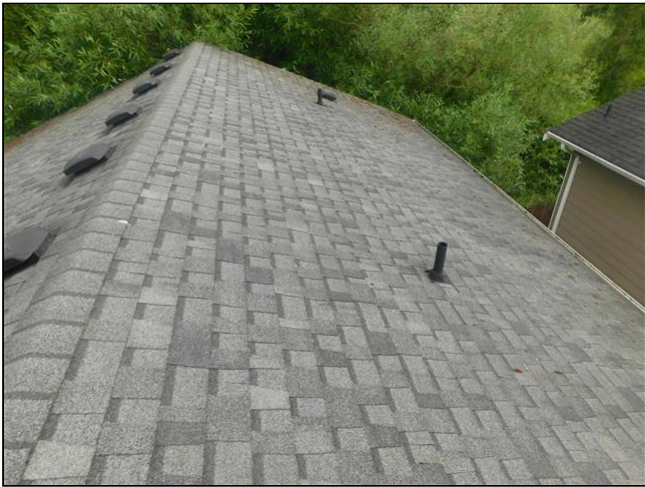
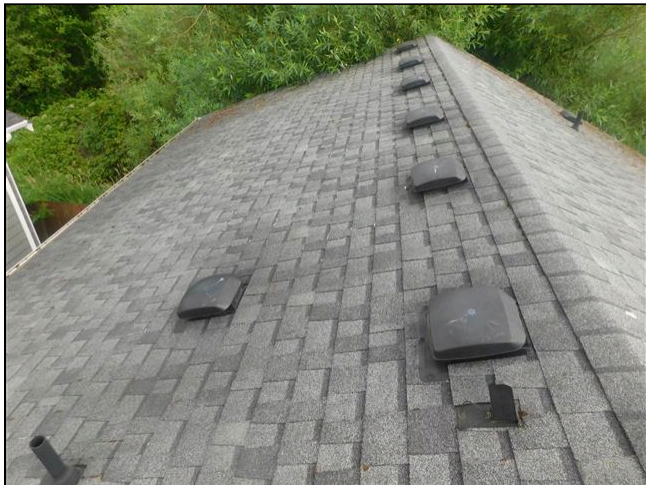
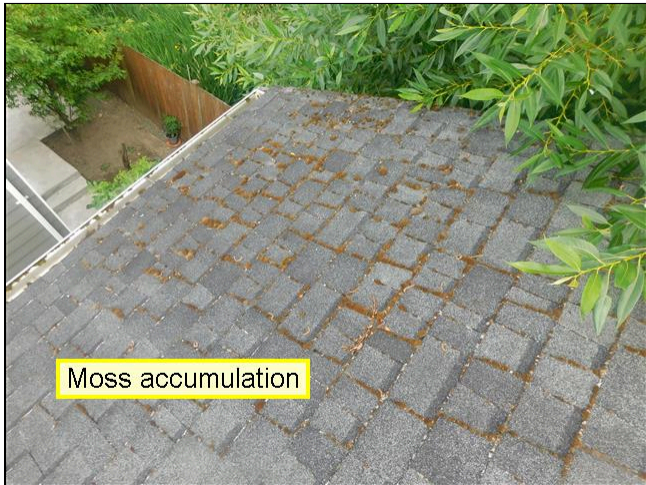
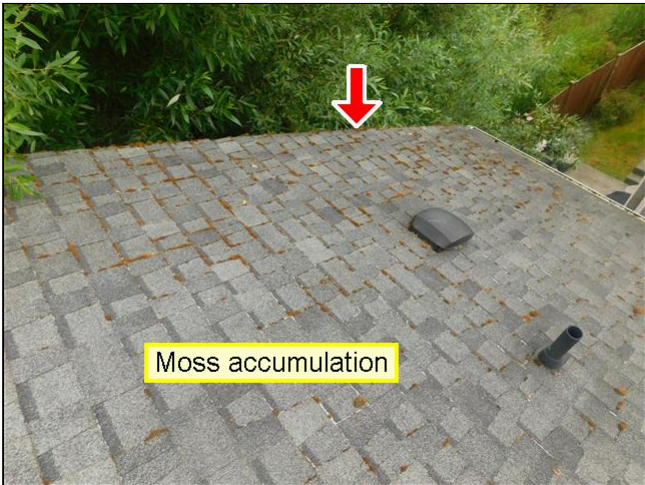
Roof: 30 year architectural composition roof product: Roof appears to be in good shape at the time of inspection. No shingles are missing. Proper flashing. Proper ventilation. Roof is 15 years old. Roof will last at least another 5 years with routine maintenance.

Roof: Typical moss accumulation. Recommend routine cleaning to keep the moss to a minimum.

Roof: Tree hanging over roof. Recommend removing tree from away from roof. Repair.

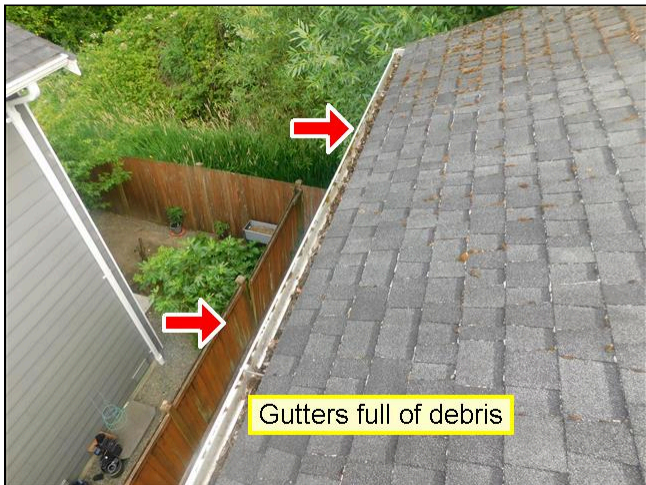
3.3 Item 1(Picture)

Gutters are full of debris. Gutters need to be cleaned. Recommend routine cleaning of gutters.

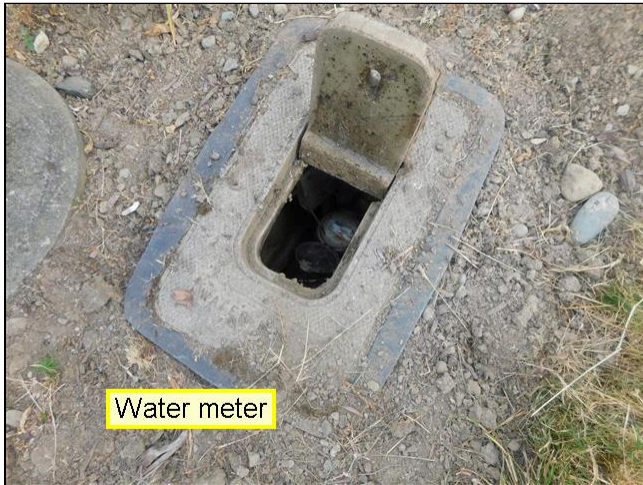
4.0 Item 1(Picture)

**4.0** Inspected the water meter when no water was running in the house. If water meter was running it would indicate that there could be a leak in the water service line from the meter to the house.

Meter was not running. This indicates there is no water leak in the water main from the meter to the house.

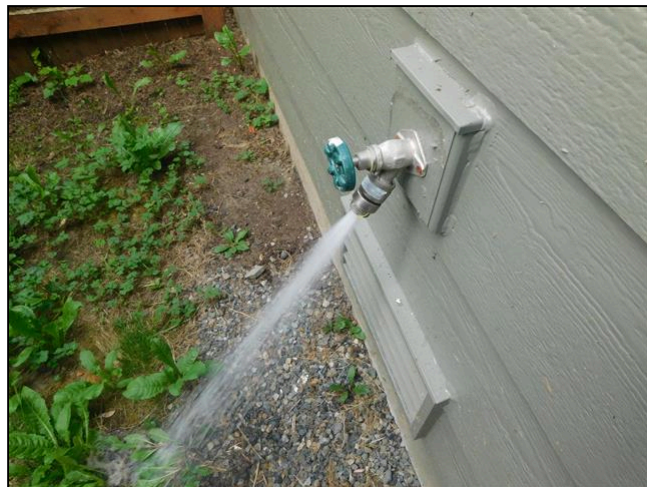
**4.1** Good water pressure at both hose bibs.

Recommend hose bib cover on exterior hose bib during winter months.

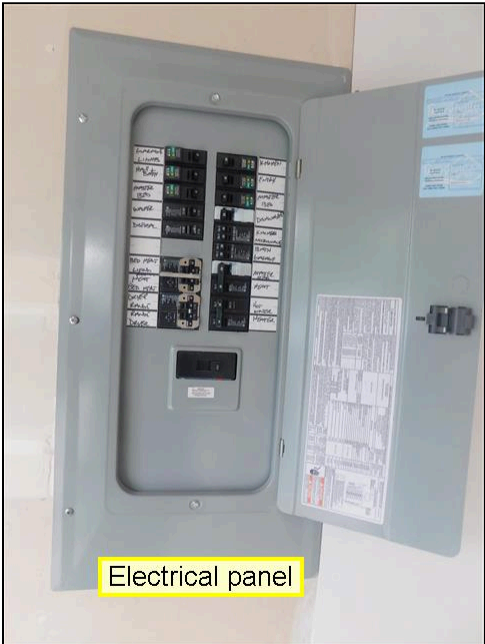
5.1 Item 1(Picture)

Inspected inside of panel. All connections are correct. No hazards found.

Electrical panel: Defective arch fault breaker. Replace breaker. Repair.

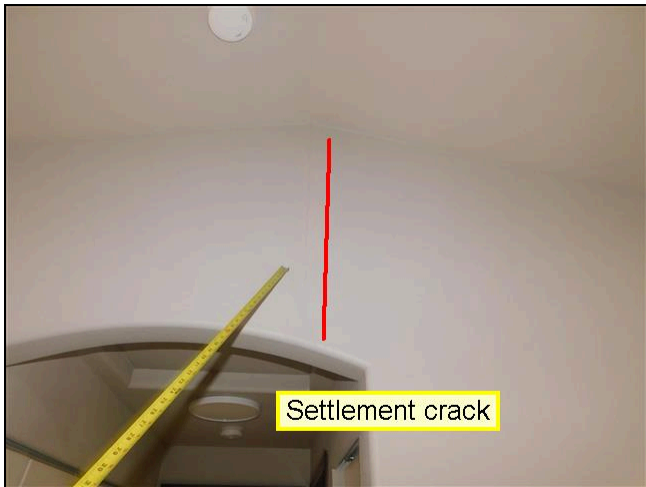
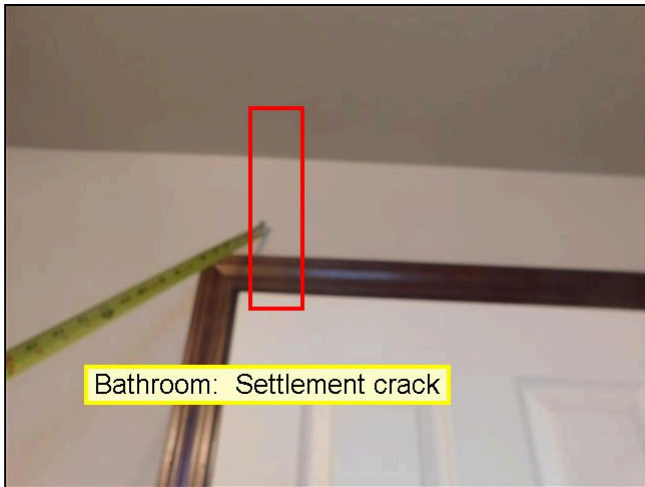
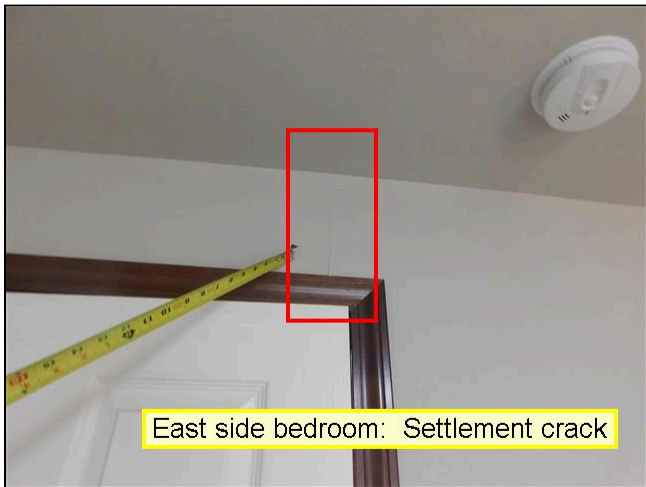
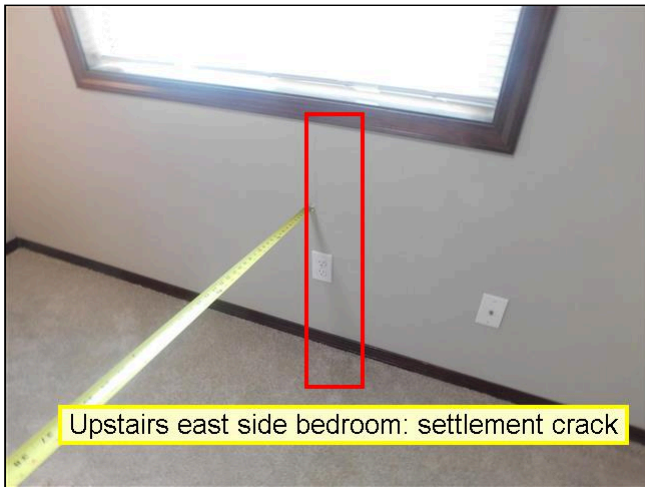
Upstairs: Found several walls where settlement cracks are visible. This is not a structural issue. Recommend re-taping all cracked drywall, texture and paint. Repair.

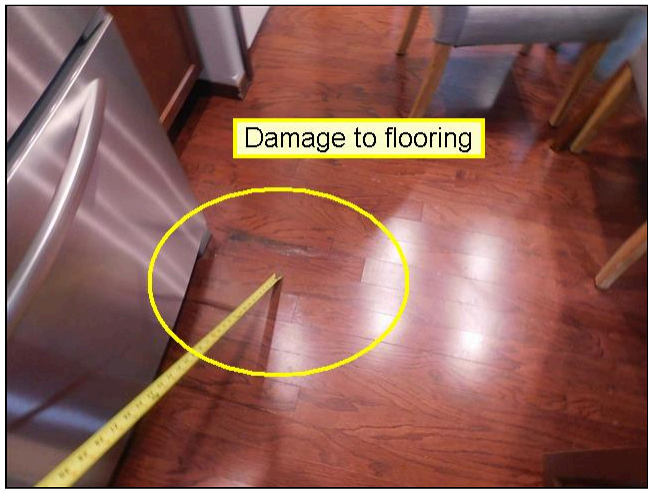
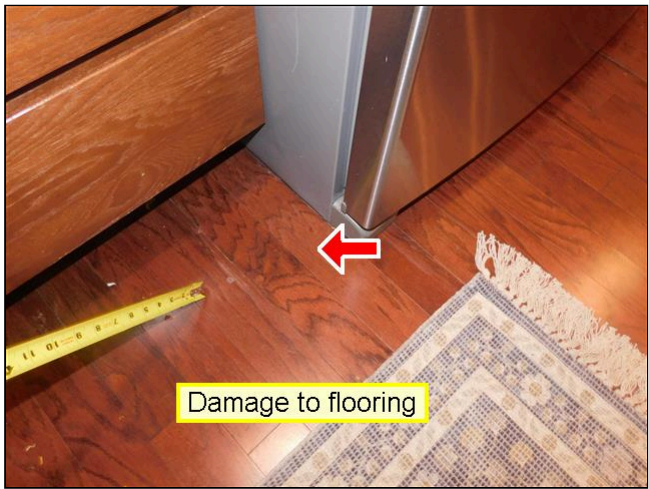
Kitchen: Water damage to engineered hardwood flooring. Repair.

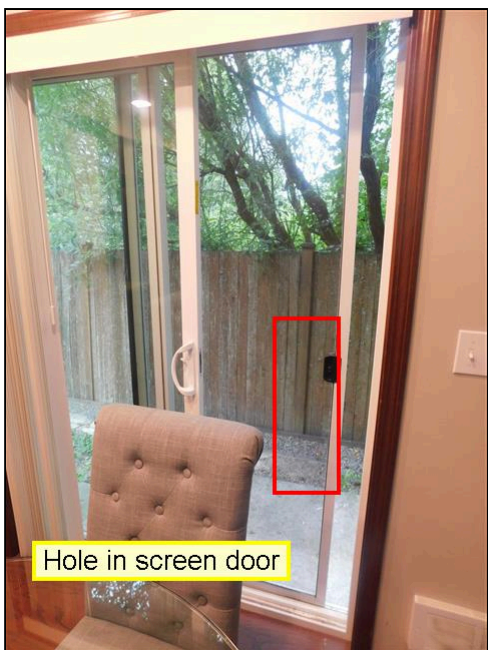
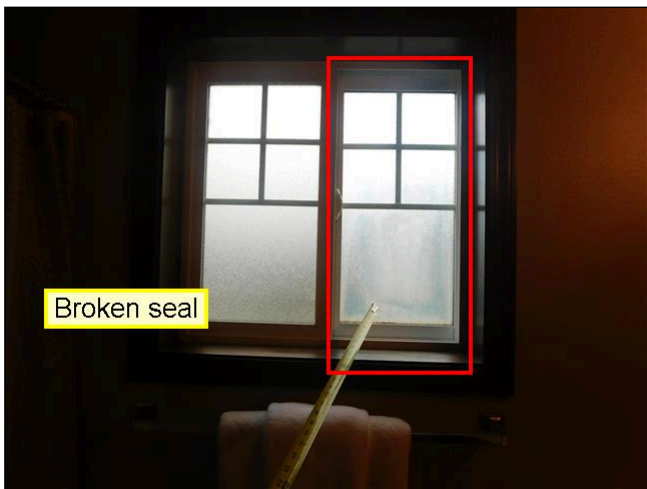
- 
- Living room east wall: Window has broken seal. Recommend reglazing this window. Repair.
- Dining area: Slider screen door has holes in the screening. Recommend re-screening this door. Repair.
- 
- South bedroom: Window screen is damaged. Replace screen. Repair.
- Upstairs hallway bathroom: Window has broken seal. Recommend reglazing this window. Repair.

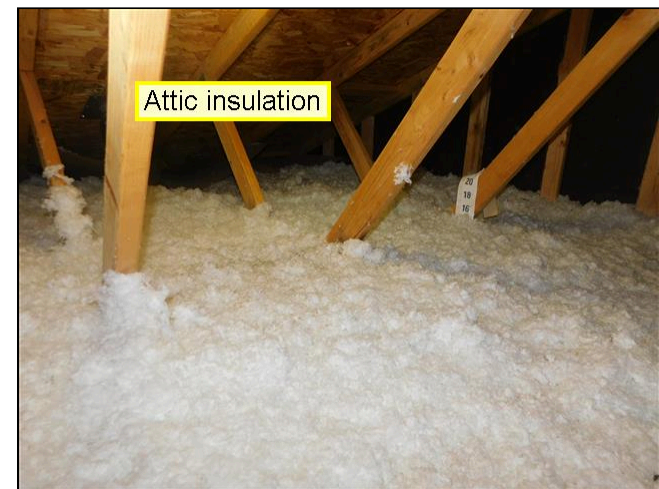
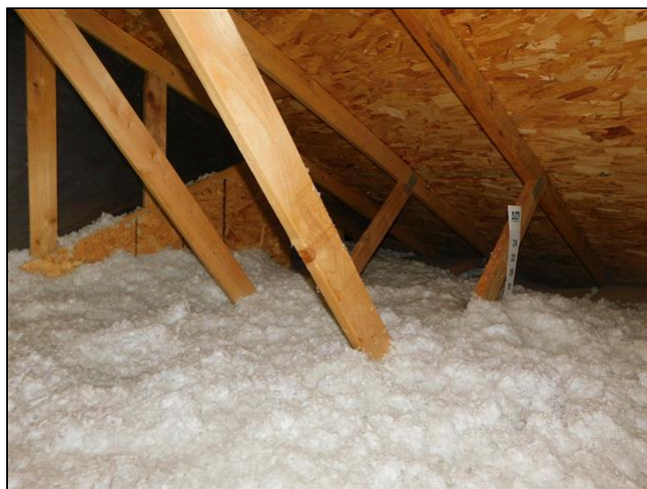
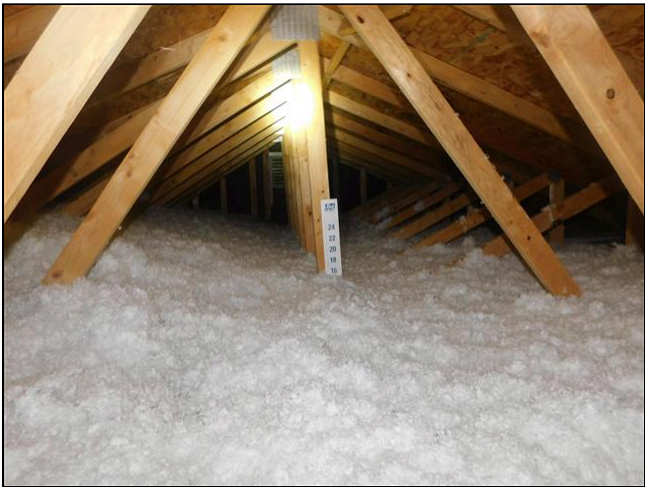
Attic: Insulation is in place. No recommendations.

Floor insulation in place. No recommendation.

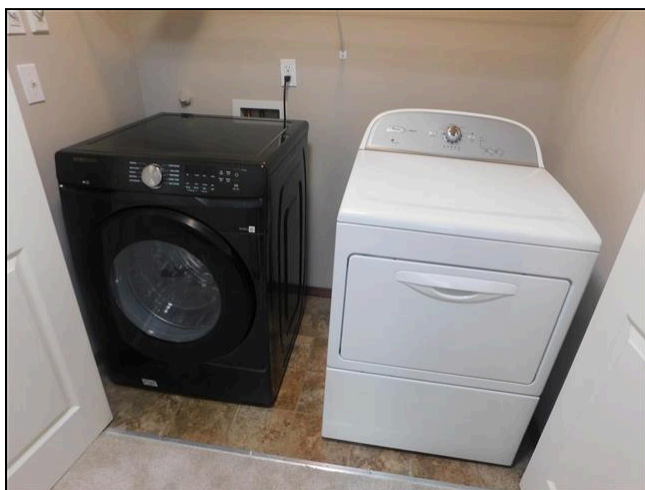
Front load washer was not filled at the time of the inspection. Not inspected.

**High pressure hoses in place.**
